Close Out Documents

AP-185 – 4542 Fillmore St.

Structural Demolition

Structure Survey Assessment Report AP-185

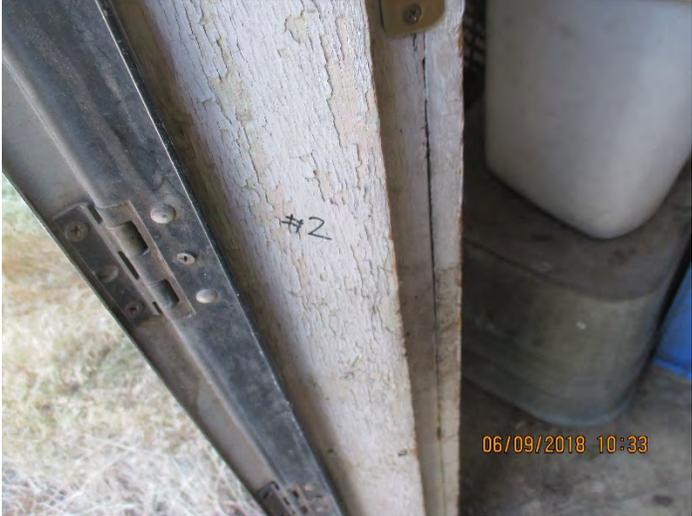
White - LCP

Samples Represented –
4542F-R9-2L
4542F-2Q

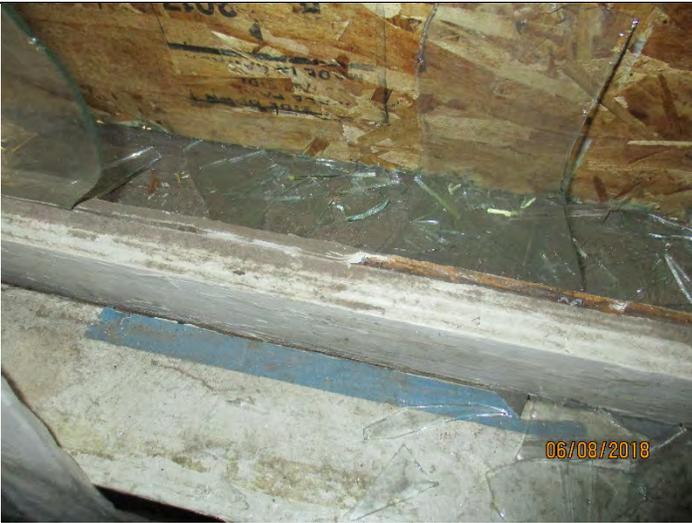
Lt. Blue/White - LBP

Sample Represented –
4542F-R3-5L

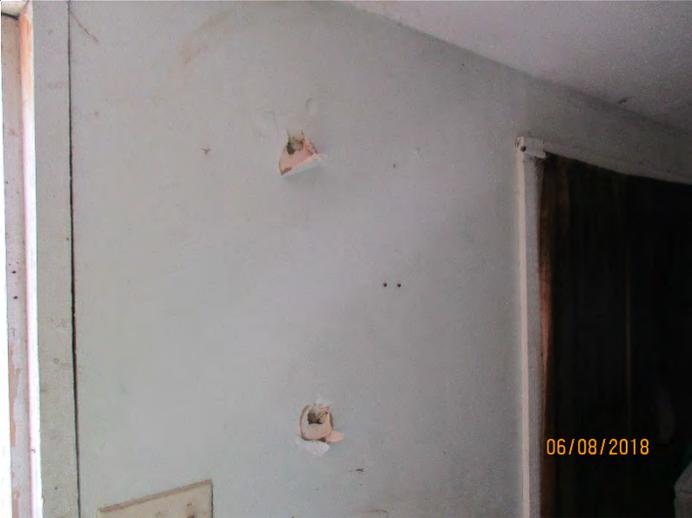
Robin Egg Blue - LBP

Sample Represented –
4542F-R5-6L

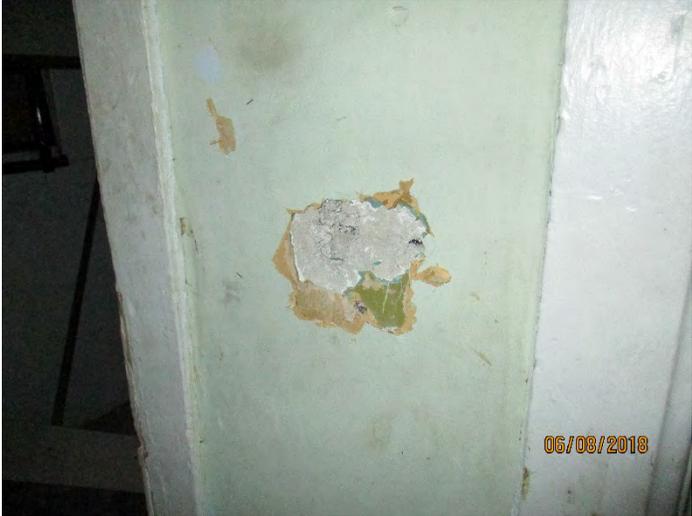
Light Blue/Green - LBP

Sample Represented –
4542F-R5-7L
